**DEPARTMENT OF TRANSPORTATION**

Contract #: 04-0120F4Cty: SF/ALA Rte: 80 PM: 13.2/13.9File #: 99.28**WELDING INSPECTION REPORT****Resident Engineer:** Casey, William**Address:** 333 Burma Road**City:** Oakland, CA 94607**Report No:** WIR-027098**Date Inspected:** 23-Jan-2012**Project Name:** SAS Superstructure**OSM Arrival Time:** 700**Prime Contractor:** American Bridge/Fluor Enterprises, a JV**OSM Departure Time:** 1530**Contractor:** L & M Industrial Fabricators**Location:** Tangent, Oregon**CWI Name:** Tom Dreyer**CWI Present:** Yes No**Inspected CWI report:** Yes No N/A**Rod Oven in Use:** Yes No N/A**Electrode to specification:** Yes No N/A**Weld Procedures Followed:** Yes No N/A**Qualified Welders:** Yes No N/A**Verified Joint Fit-up:** Yes No N/A**Approved Drawings:** Yes No N/A**Approved WPS:** Yes No N/A**Delayed / Cancelled:** Yes No N/A**Bridge No:** 34-0006**Component:** Tower Head Parapet**Summary of Items Observed:**

CCO: 196 - Description: Construct parapet walls at the Tower Heads

**North Tower Chimney Parapet:**

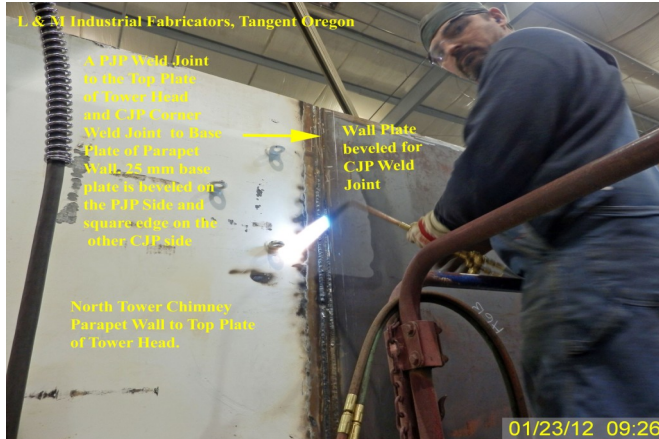
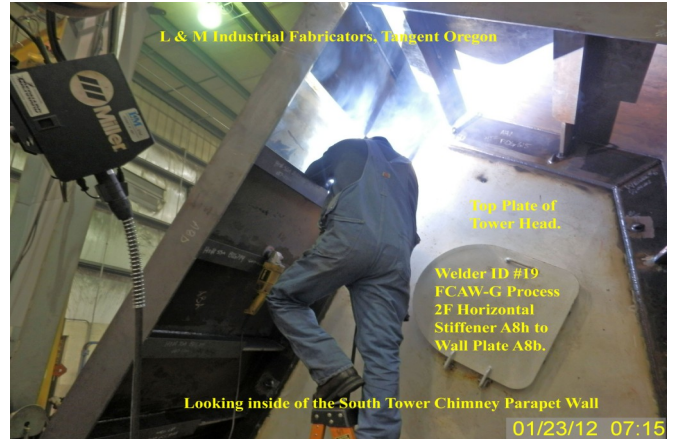
This QA Inspector observed L & M Industrial Fabricators Quality Control (QC) NDT Inspector Troy Zuecher performing NDT Magnetic Particle Test (MT) inspection on the partial-joint penetration butt-joint groove weld connecting the base plate of the parapet wall to the South Chimney Tower Head top plate. This QA Inspector also observed NDT Inspector Troy Zuecher performing NDT Ultrasonic Test (UT) inspection on the complete-joint penetration (CJP) corner-joint groove weld. The NDT was performed in accordance with L & M Industrial Fabricator's Weld Quality Control Plan (WQCP) as ABF Submittal 2510 Rev. 1.

A4a base plate PJP welded to South Tower Head Top Plate- (8) MT Linear and Transverse Indications detected.  
A4a base plate CJP corner joint welded to A4b wall plate- (1) UT Transverse Indication detected.  
A5a base plate PJP welded to South Tower Head Top Plate- (11) MT Linear and Transverse Indications detected.  
A5a base plate CJP corner joint welded to A5b wall plate- (2) UT Transverse Indications detected.  
A6a base plate PJP welded to South Tower Head Top Plate- No MT Linear or Transverse Indications detected.  
A6a base plate CJP corner joint welded to A6b wall plate- (1) UT Transverse Indication detected.  
A7a base plate PJP welded to South Tower Head Top Plate- No MT Linear or Transverse Indications detected.  
A7a base plate CJP corner joint welded to A7b wall plate- No UT Linear or Transverse Indications detected.  
A8a base plate PJP welded to South Tower Head Top Plate- (1) MT Transverse Indication detected.

A8a base plate CJP corner joint welded to A8b wall plate- No UT Linear or Transverse Indications detected.

This QA Inspector was informed by CWI Inspector Tom Dreyer that L & M Industrial Fabricators will prepare a repair procedure to offer for approval on the MT Linear and Transverse Indications on the base plate PJP welded to the South Tower Head Top Plate. The UT Transverse Indications detected will be repaired using the repair procedure submitted under ABF Submittal 2510 Rev. / Addendum 3 on January 24th 2012.
